Manhole Inspection Summary

Manhole # S37I__037MH

Insp Date: **8/19/08 10:45 AM**

Location Address: **rear 500 e pratt st**

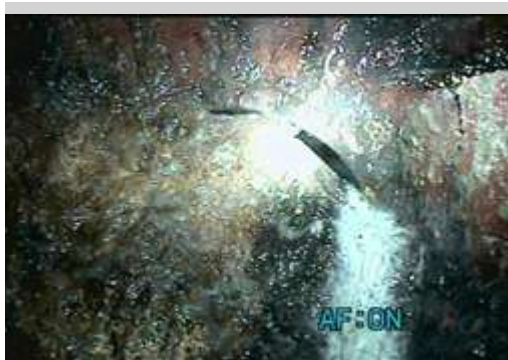
Defect 4

Infiltration: ☐ None ☐ Joint ☐ Cracks ☐ Mortar ☐ Roots ☒ **Wall**

Barrel Infiltration, Misc. sealed pipe

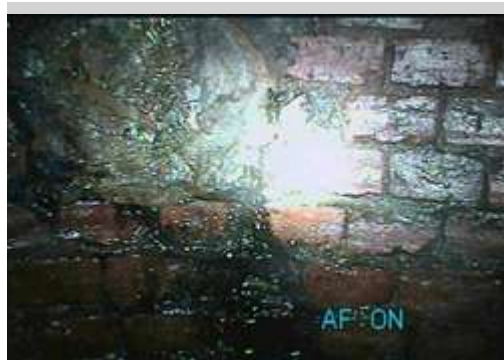
Defect 3

Infiltration: ☐ None ☐ Joint ☐ Cracks ☐ Mortar ☐ Roots ☒ **Wall**

infiltration in corbel and chimney

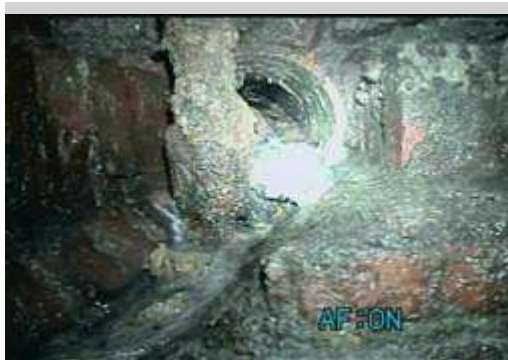
Defect

Condition: ☐ Sound ☐ Cracked ☐ Root Intrusion ☐ Deteriorated ☐ Leaks ☒ **Debris**

channel debris

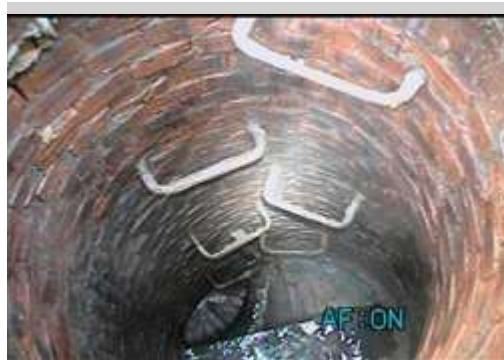
Defect 2

Count: **6** Missing: **0** ☒ **Corroded**

corroded steps

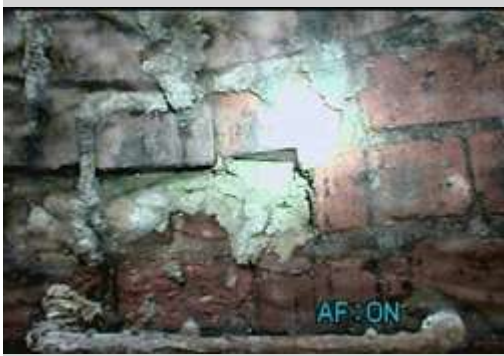
Defect 1

Condition: ☐ Sound ☐ Cracked ☐ Root Intrusion ☒ **Loose Brick** ☒ **Deteriorated**

chimney loose bricks and deteriorated
frame adj

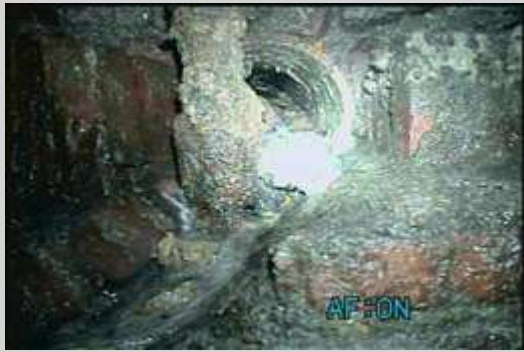
6 O'Clock Inflow

to much debris to see inside
